Manhole Inspection Summary

Manhole # S61I__028MH

Insp Date: **3/18/08 10:06 AM**

Location Address: **519 Tolan St.**

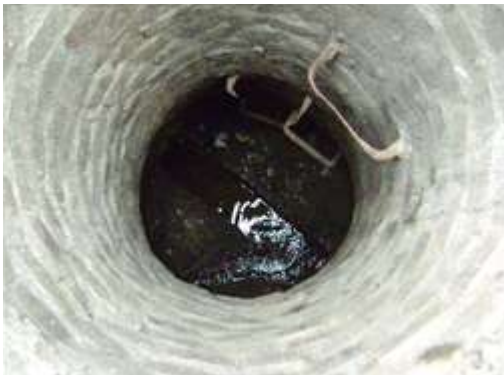
Defect 2

Condition: ☐ Sound ☐ Cracked ☐ Root Intrusion ☐ Deteriorated ☐ Leaks ☒ **Debris**

Count: **4** Missing: **1** ☒ **Corroded**

Infiltration down wall of corbel/barrel, debris on bench, and steps corroded.

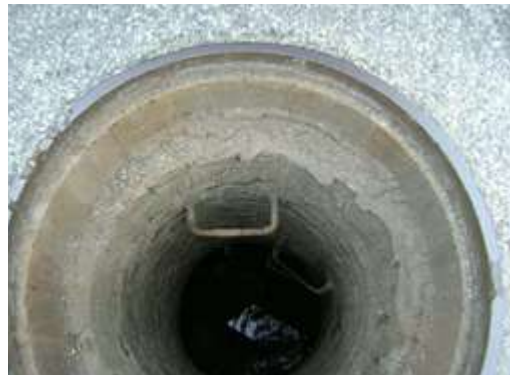
Defect 1

Offset: **3** (in.)

Condition: ☐ Sound ☒ **Cracked** ☐ Leaks

Offset at chimney

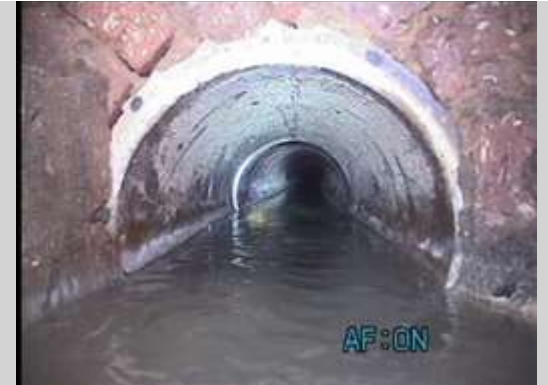
12 O'Clock Outflow

10 in. Circular Gravity Sewer
Pipe Out @ 12 O'Clock

Pipe Height: **9.6** (in.) Rod and Bar (Angled)
Pipe Material: **Clay** ☐ Pipe Lined
Invert Depth: **11.75** (ft.) Flow Characteristics: **Fast**
Deposits: ☒ None ☐ Mud ☐ Sludge ☐ Debris ☐ Grease
Silt Depth: (in.) Deposits Extent:
Infiltration: **None** Pipe Seal Cond: **Sound**

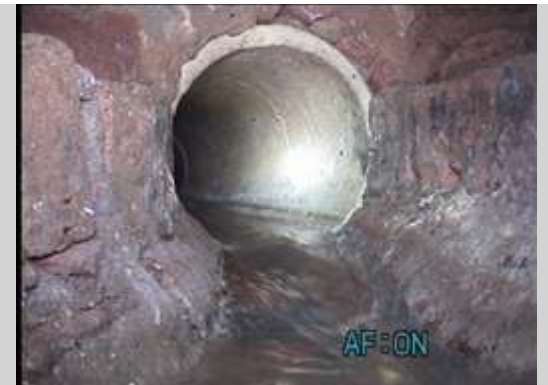
3 O'Clock Inflow

8 in. Circular Gravity Sewer
Pipe In @ 3 O'Clock

Pipe Height: **8.4** (in.) Rod and Bar (Angled)
Pipe Material: **Clay** ☐ Pipe Lined
Invert Depth: **11.42** (ft.) Flow Characteristics: **Fast**
Deposits: ☒ None ☐ Mud ☐ Sludge ☐ Debris ☐ Grease
Silt Depth: (in.) Deposits Extent:
Infiltration: **None** Pipe Seal Cond: **Sound**

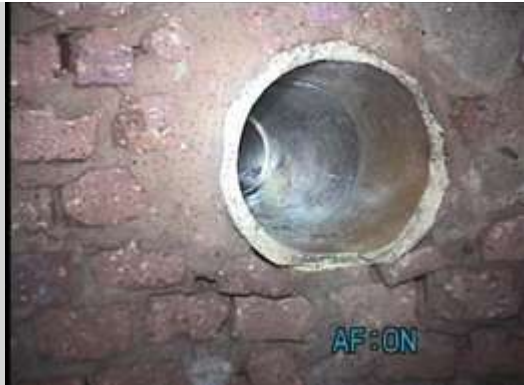
6 O'Clock Inflow

Pipe Height: **8.4** (in.) Rod and Bar (Angled)

Infiltration: **None** Pipe Seal Cond: **Sound**

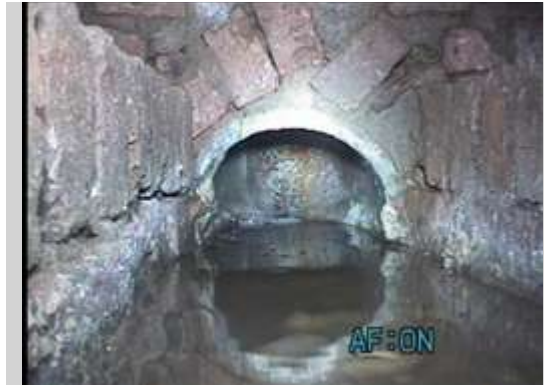
Drop In @ 6 O'Clock

Drop: **Outside** Rod and Bar

Drop Condition: **Open**
